## **Recent Developments with Seal Coating in Alberta**

Jim Gavin, P. Eng.  
Roadway Construction Standards Specialist

Alberta Transportation  
Edmonton, Alberta

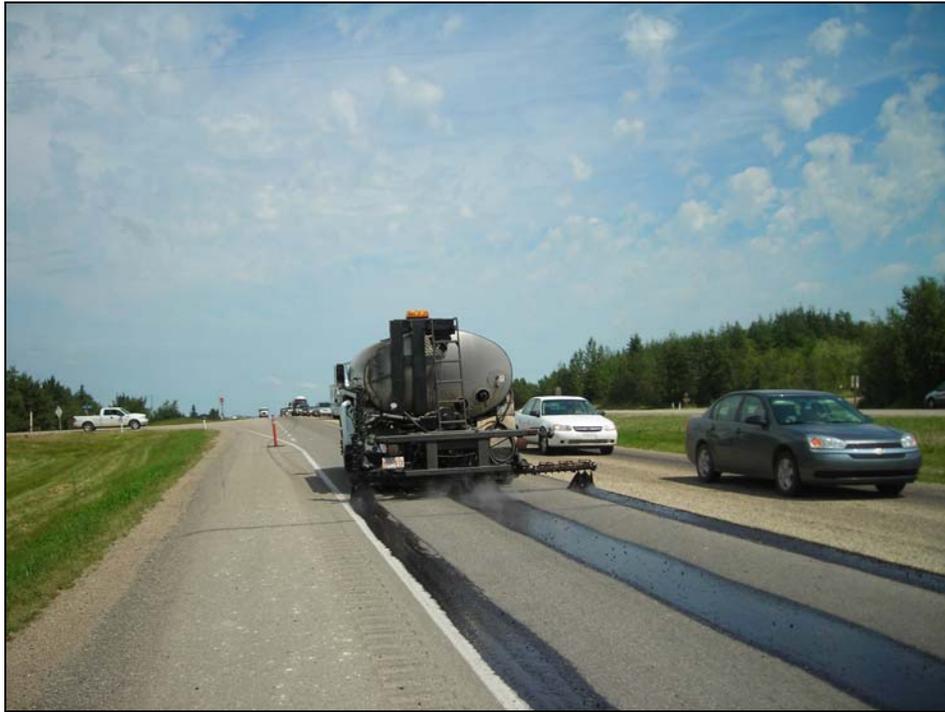
**Photo 1. Pre-Spray Binder Application**

Two seal coat performance problems commonly seen on high volume highways within Alberta are related to not achieving two different application rates within the same travel lane - that being flushing within the wheel paths (application too high) and chip loss or snowplough damage along the centre-line joint or outer edge of application (application too low). To address those problems Alberta Transportation has used, on a trial basis, a two-stage application process where two asphalt distributors work in close tandem. This procedure has been successfully used in New Zealand and Australia [6]. The first distributor applies a light application of approximately 0.3 l/m<sup>2</sup> to the non-wheel path surfaces (i.e. two strips on the outside and one strip between the wheel paths). A second distributor sprays the entire lane at a target application rate which is appropriate for a high volume highway (Photos 1 and 2).

The light application (pre-spray) rate is meant to represent the difference in design rates due to different traffic volumes (i.e. non-wheel path surfaces have a lower traffic factor). This procedure was successfully used in 2008 on the outer travel lane of the Queen Elizabeth II highway (Hwy 2) near Red Deer. The performance to-date has been good as little to no wheel path flushing has been observed along with no aggregate loss or snowplough damage. It is possible that this procedure could help, albeit marginally, in reducing the instances of loose chips during construction.

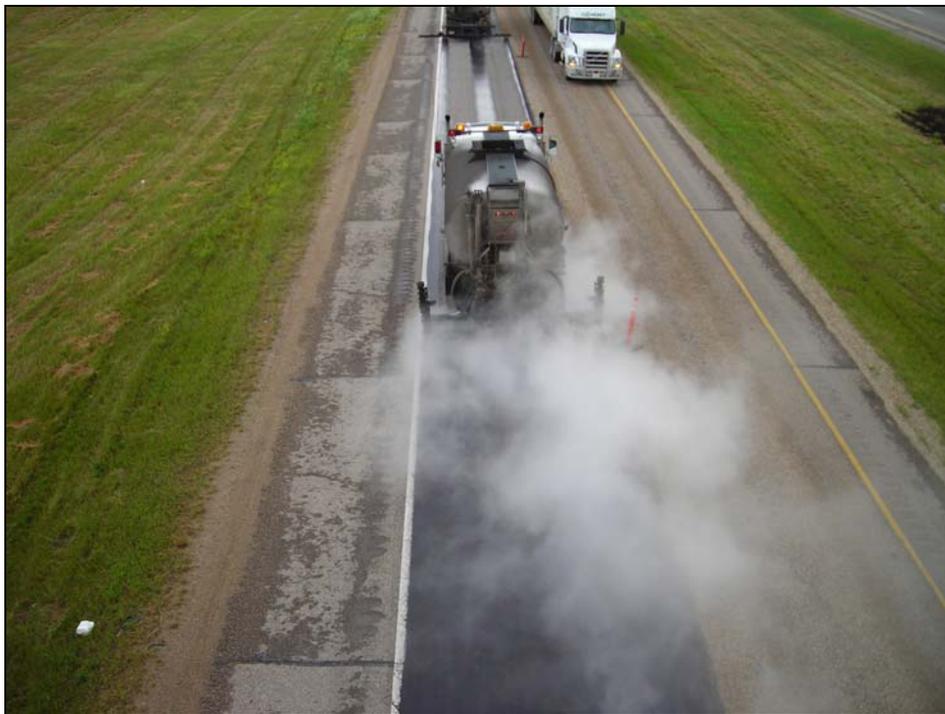
**Photo 2. Regular Application with a Second Distributor**

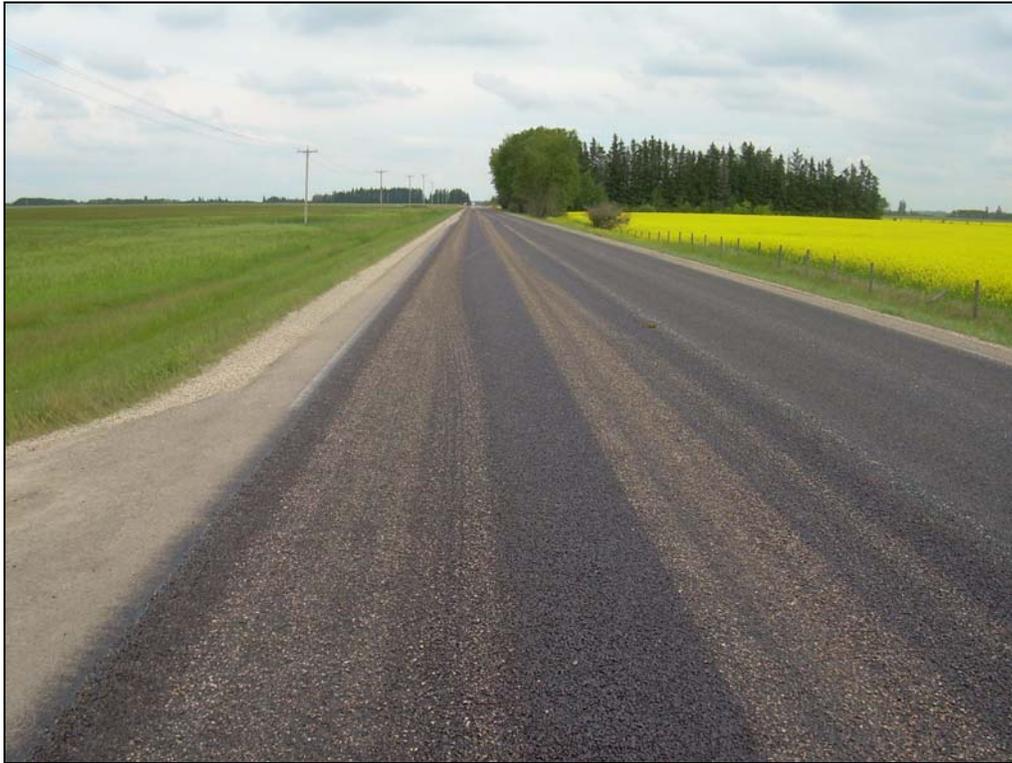
**Photo 3. Tire Tracking on Insufficiently Cured Fog Seal**

While there appears to be a benefit in using this technique there are also a few disadvantages. The fog sealing procedure requires extra lane closure time (2 to 3 hours) while the fog seal cures resulting in extra travel delays. The procedure also reduces the amount of chip sealing that can be done per day as the curing of the fog seal must be complete prior to dusk and the opening of all lanes to traffic. There is also the risk of motorists inadvertently driving on the fresh fog seal and thus generating further complaints (Photo 3.) For those reasons, the Department and contractors are reluctant to include fog sealing as a normal procedure. The use of blotting sand on top of the fog seal has not been used by the Department but may be worth pursuing in the future to lessen some of these risks.

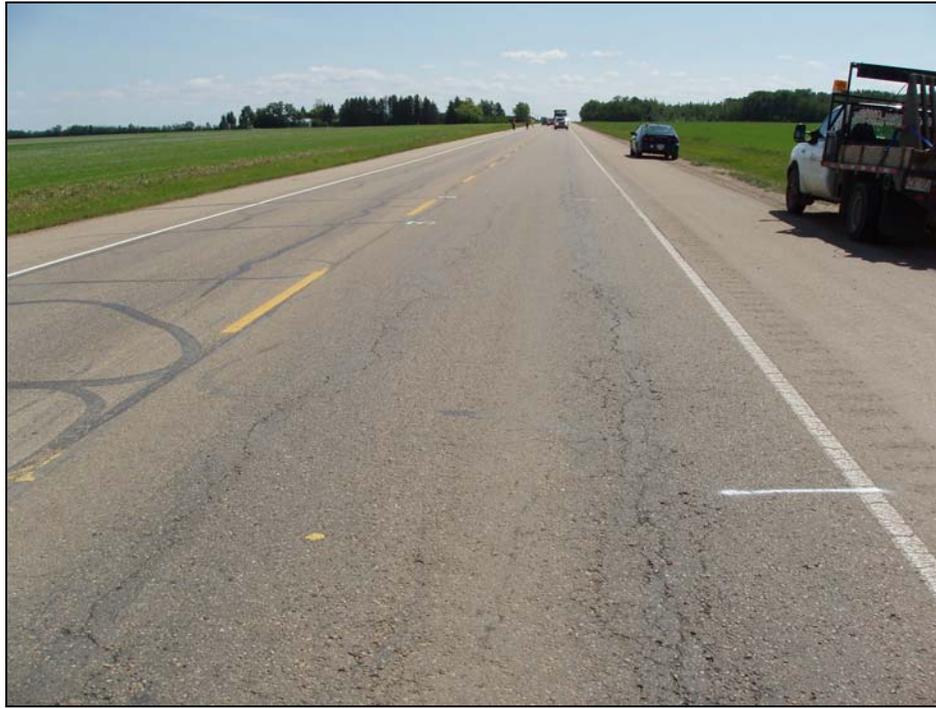
**Photo 4. Hwy 39:10 - Extensive Wheel Path Cracking of Slight Severity**

This pavement was last paved in 1999 and the factors that contributed to its high ranking were high frequency of pavement segregation areas, extensive areas of hairline distress cracking within the wheel paths (Photo 4), and high traffic volumes. Transverse cracking of slight to moderate severity was present at a spacing of 10 to 20 m. Because of the extensive wheel path cracking this project was considered a good candidate to trial the fibre-reinforced membrane system and its ability to mitigate this form of cracking. Regular chip seals are considered to be only moderately successful in that regard. The racked-in process for aggregate application was also used with the fibre-reinforced membrane. Accordingly, the two different products will be described in this report as racked-in (with fibres) and racked-in (without fibres).

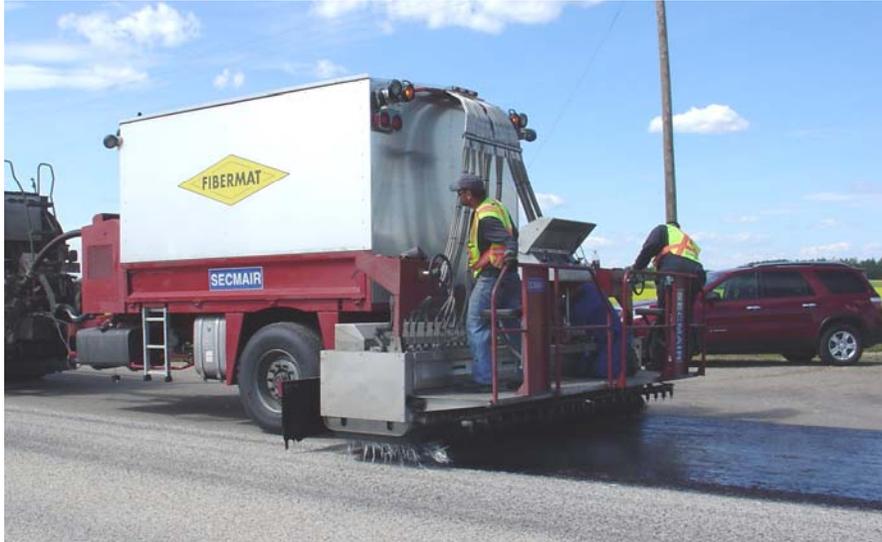
**Photo 5. Fibre-Reinforced Membrane Placement Trailer Unit**

The specialized trailer used to apply the emulsion and fibres is shown in Photo 5. The fibre-reinforced membrane, before chip placement, is shown in Photo 6. The application of the two aggregate layers is shown in Photos 7 and 8.

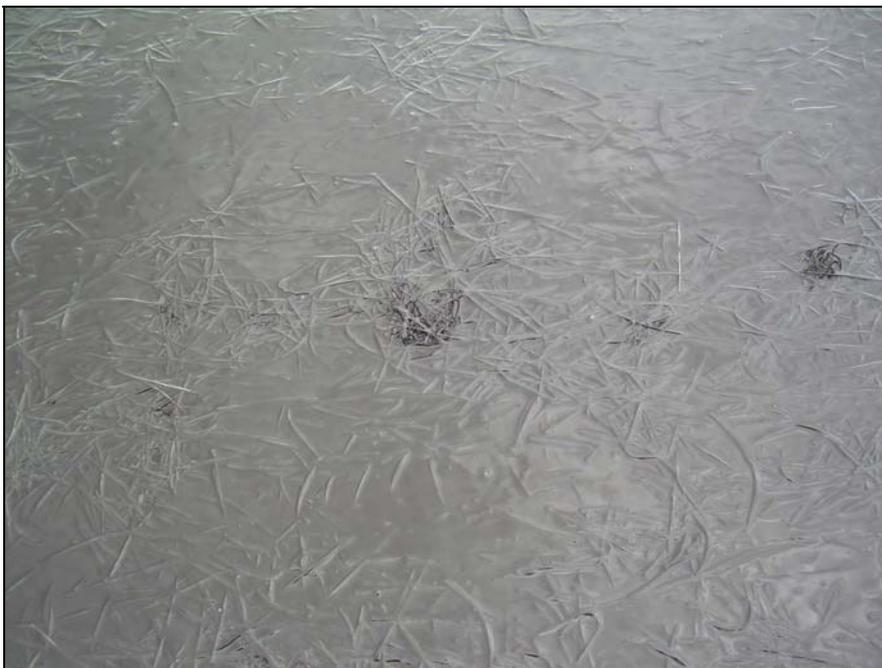
**Photo 6. Fibre-Reinforced Membrane Prior to Chip Application**

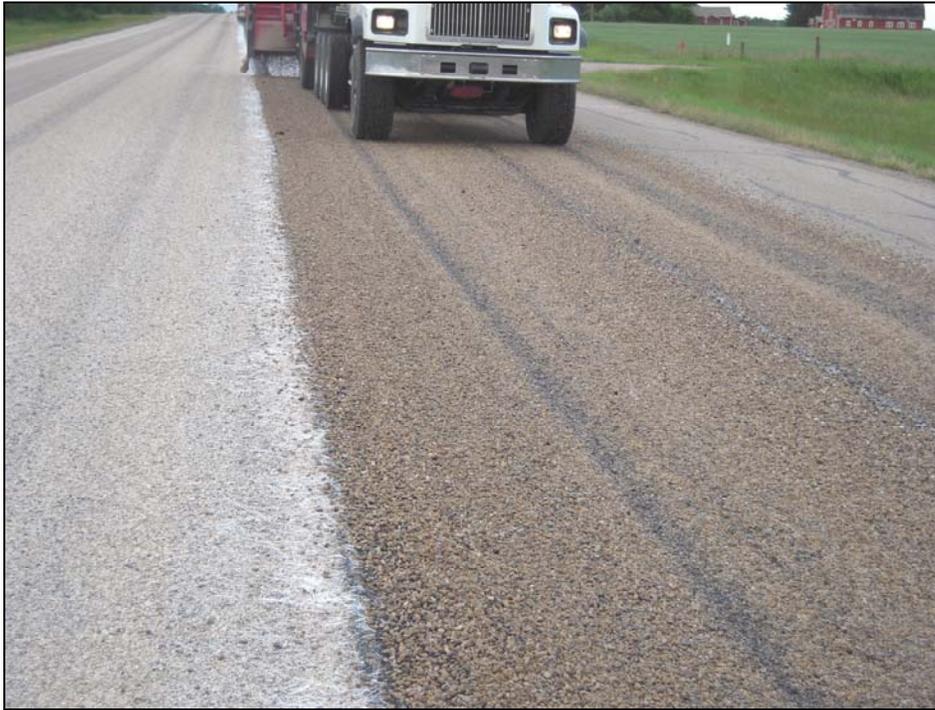
**Photo 7. Fibre-Reinforced Membrane with 1<sup>st</sup> Layer of Racked-In Aggregate**

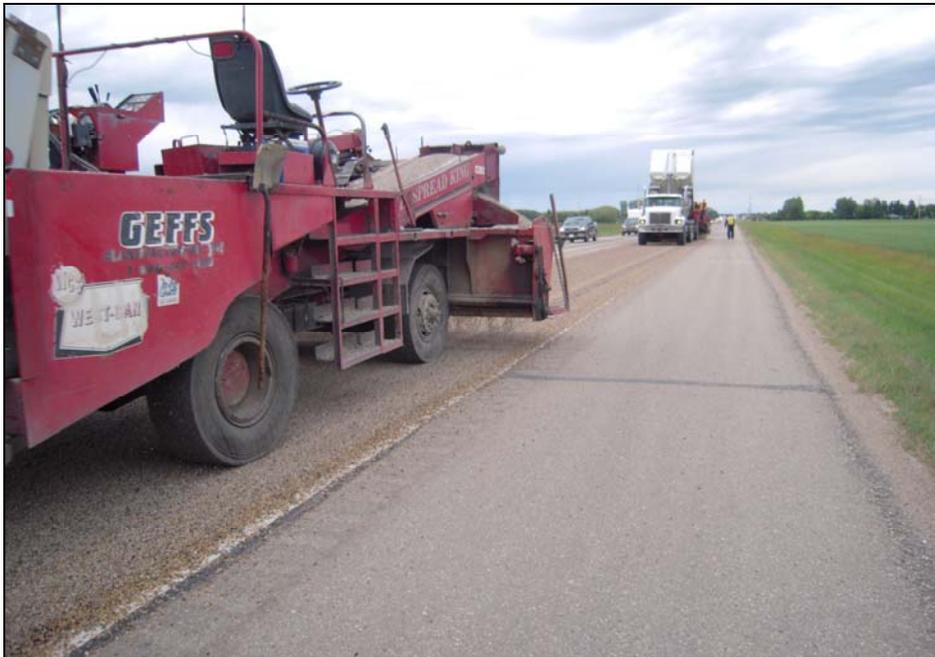
**Photo 8. Application of Smaller Chips**

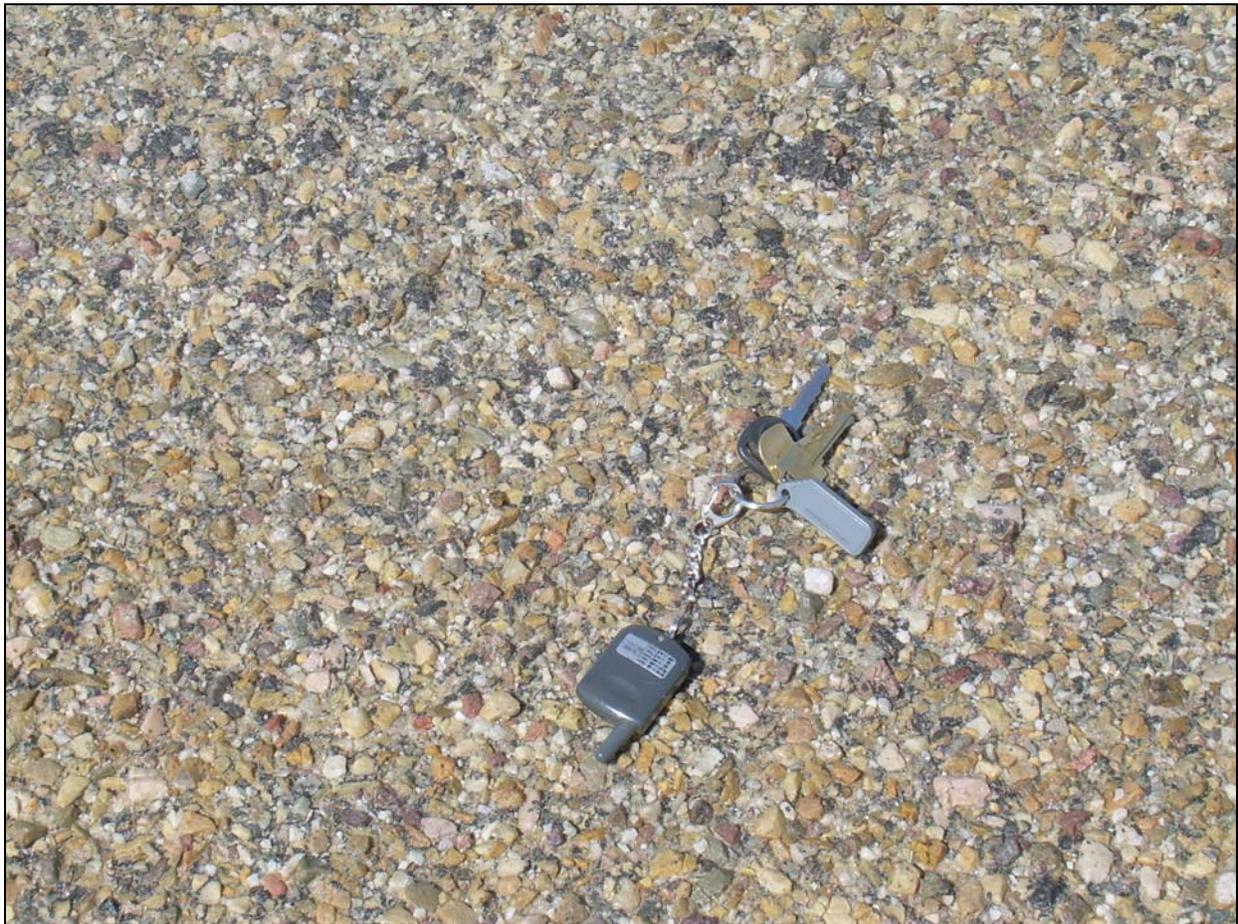
**Photo 9. Close Up Appearance of Racked-In Seal (With Fibres)**

The typical appearance of the completed racked-in seal coat is shown in Photos 9 and 10. As expected, it was difficult to discern between the two products (with and without fibres) based upon surface appearance. The appearance somewhat resembles a chip seal surface, however the smaller choke chips were clearly wedged within the matrix of the larger chips. The quality of the final product was considered to be very good. Some of the transverse joints, where either of the asphalt distributors stopped and started, did display localized areas of unequal binder application (minor flushing).

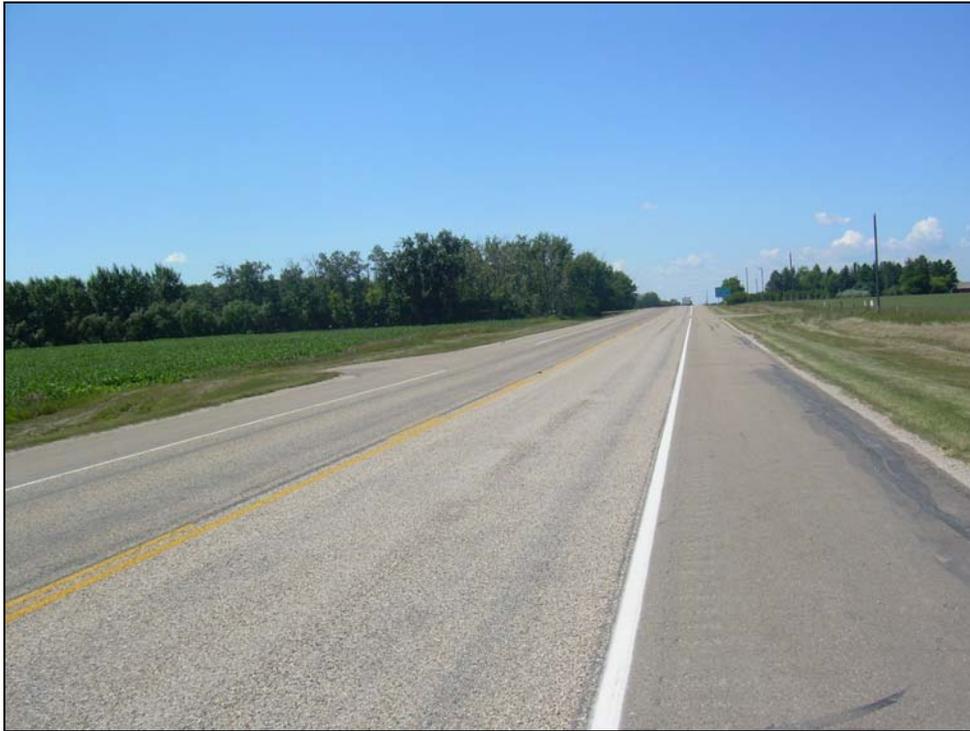
**Photo 10. Racked-In Seal Coats – Without Fibres in Near Lane, With Fibres in Far Lane**
